**NAVAL FACILITIES ENGINEERING SERVICE CENTER**
Port Hueneme, California 93043-4370

TM-2328-SHR

INVESTIGATION INTO ACRYLIC PAINT CRACKING (APC) ON ASPHALTIC PAVEMENTS

Jan 2000

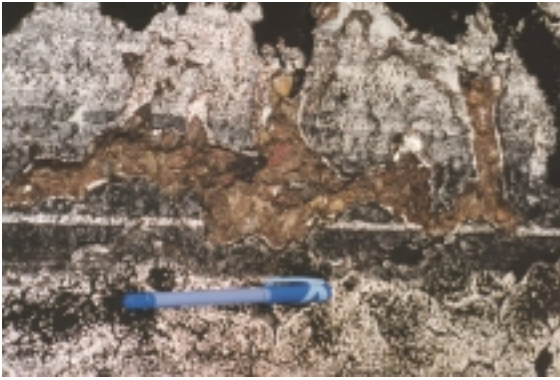
APC, NAS North Island.

outlined by cracks. In general, APC penetrated the full 3/8" SS depth and, in some cases, cracking was observed to a depth greater than 1".

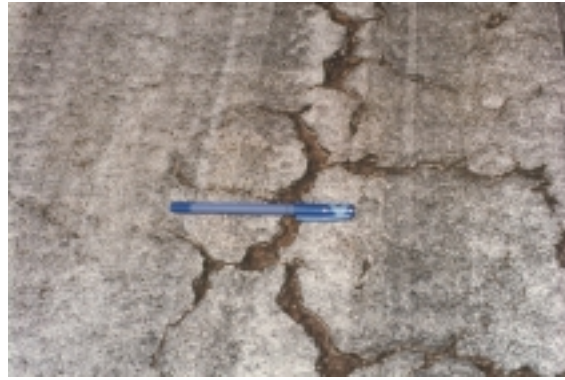
APC, NAS North Island.

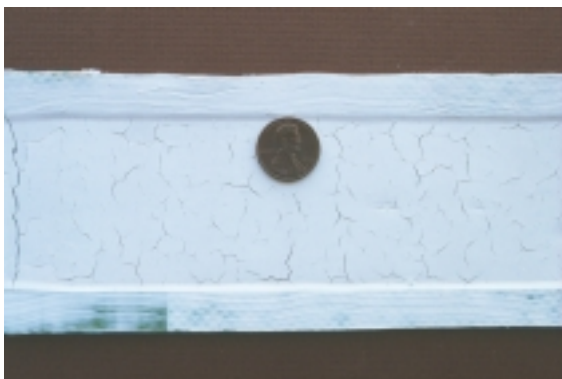
Paint I cracking at **>** 30 mils DFT.

Paint I (left), Paint HB (right).

Paint I and batch two of Paint HB displayed slight cracking at DFTs as low as 22 mils whereas batch one of Paint HB and Paint EA were crack free at DFTs up to 50 mils. As anticipated, the elastomeric modified acrylics (EA/I, EA/II) displayed less cracking at higher DFTs when compared to the unmodified formulations. It was disappointing to observe the high degree of variation between the two commercial batches of Paint HB. The first batch of Paint HB displayed excellent crack resistance whereas the second batch displayed cracking at approximately 1/3 the DFT of batch one.

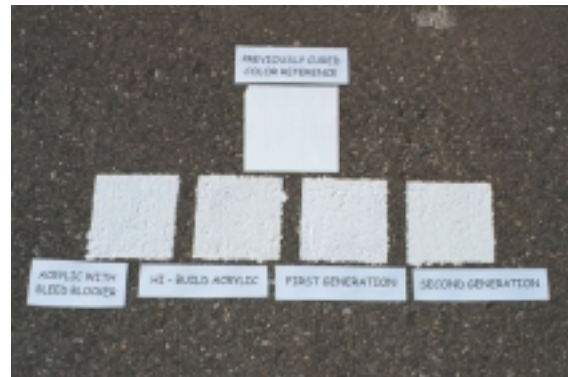
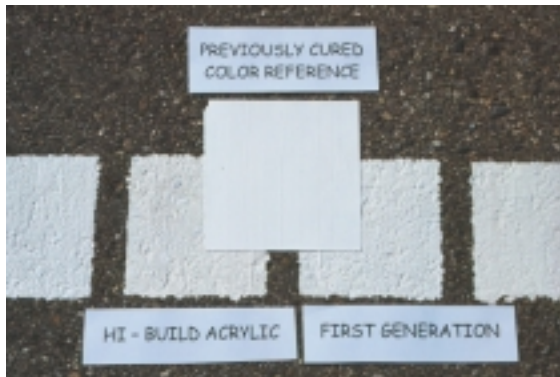
Paints HB, I displayed poor asphaltic bleed resistance.

Testing for asphaltic bleed resistance.

Paints were applied to a clean, four-year old AC surface at approximately 10 mils DFT by brush. Table 15 lists qualitative visual results for asphaltic bleed resistance whereby paint EA, doped with an asphaltic bleed-blocking agent, outperformed the acrylic marking paints.

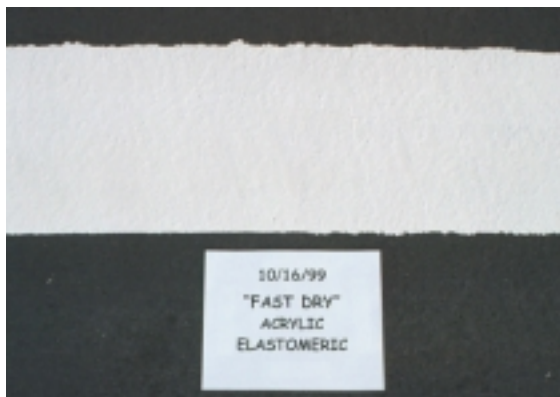
Patch applied to parking lot SS.

Crack free at 2 months: Parking lot SS patch.

Patch applied as stripe for stop sign.

Poor abrasion resistance at 2 months service: Stop sign stripe.

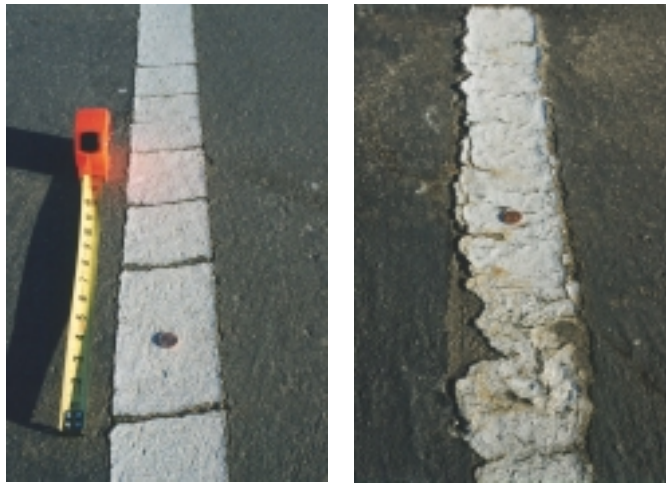
Stripes were applied at the same time: right stripe receives sprinkler runoff.

Moisture induced stress occurs when coatings absorb moisture from rainfall, high humidity, dew, and pavement moisture vapor emission. Cycling between water absorption (volume increase) and drying (volume contraction) increases cohesive and adhesive paint stress. As previously noted, the tested paints displayed water absorption weight increases ranging from 5.5 % to 12.6 %. In general, a 10 % increase in weight represents approximately a 13 % increase in volume[50]. Paints I, II displayed approximately a 10 % weight increase from water absorption and, since they also displayed poor flexibility, should weather poorly when subjected to high levels of moisture. As evident in the above photographs, high levels of moisture accelerate acrylic marking paint failures.
